NBSIR 83-2701

Comparative Analysis of Thermographic Inspections Performed on Retrofitted Homes

May 1983

Yui-May L. Chang
Richard A. Grot

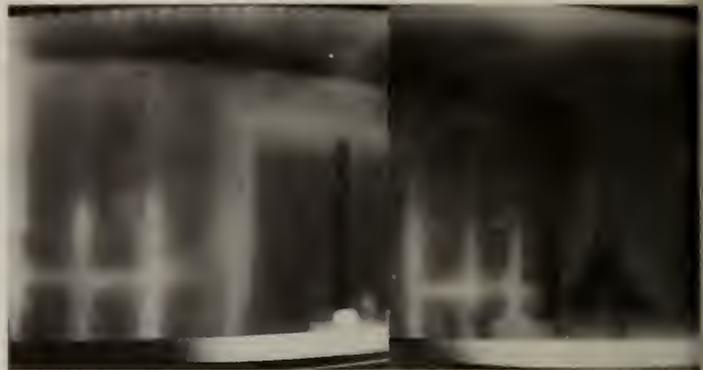
3-3

Solar patterns
observed on the S
wall of SW bedroom
(by NBS)

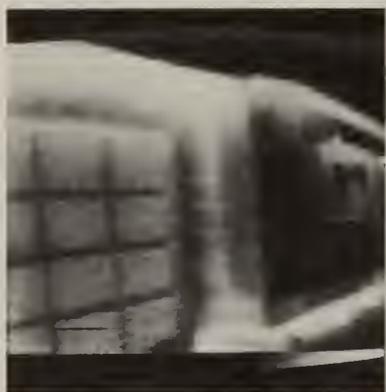
7-3

Air leakage at corner of garage on E side (by NBS)

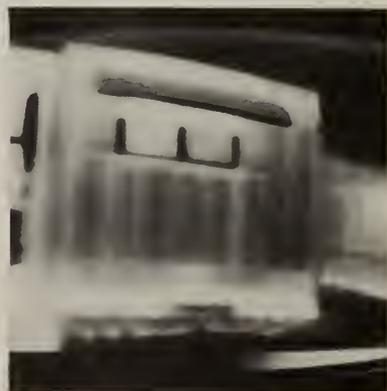
7-6

Warm brick foundation on W side indicating by-pass heat loss (by NBS)

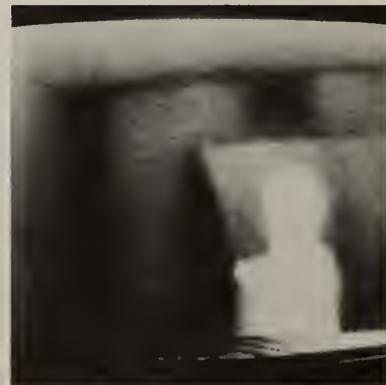
8-6

Missing insulation on N wall of bedroom (by NBS)

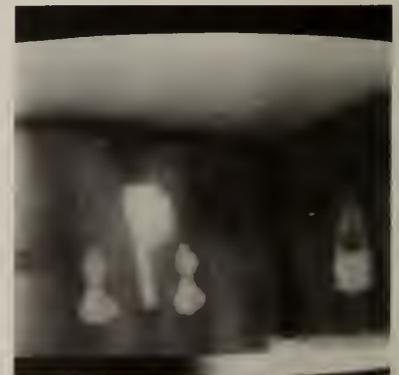
11-9
Defective area observed at SE corner of SE bedroom, as shown in 11-6, 11-8 (by NBS)

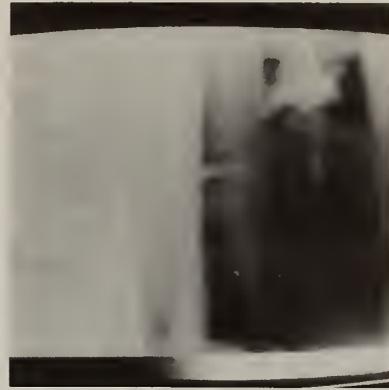
13-2

Voids and air infiltration under window on W wall of bathroom on first floor (by NBS)

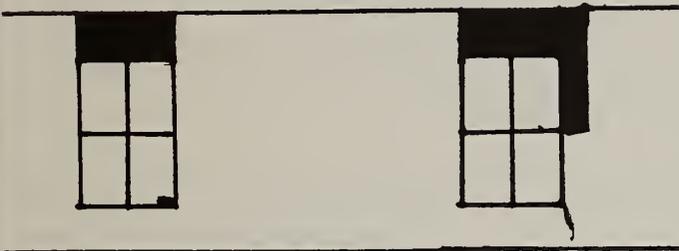
13-3

Voids over both windows and in first half bay cavity to right of N window on W wall of W bedroom (by contractor P1)

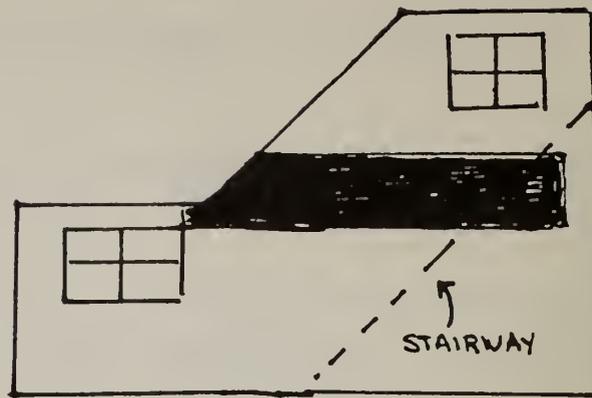
Horizontal void most likely due to framing change
Approx area - 30 FT²

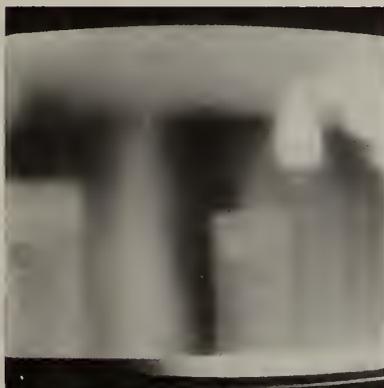
14-8

Voids above window and location of fireplace chimney on S wall of SW bedroom, 2nd floor (by NBS)

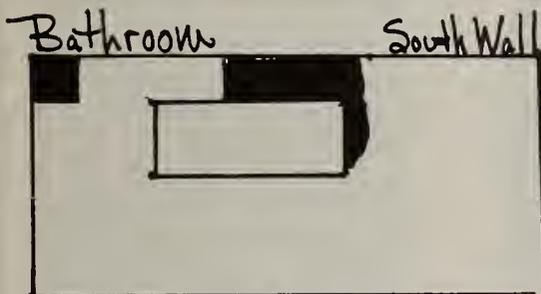
Small void in east corner as shown 1 ft^2
Insufficient insulation above & to right of window, shrinkage. 4 ft^2 ✓

15-3
Voids and shrinkage observed in S wall of bathroom (by contractor P1)

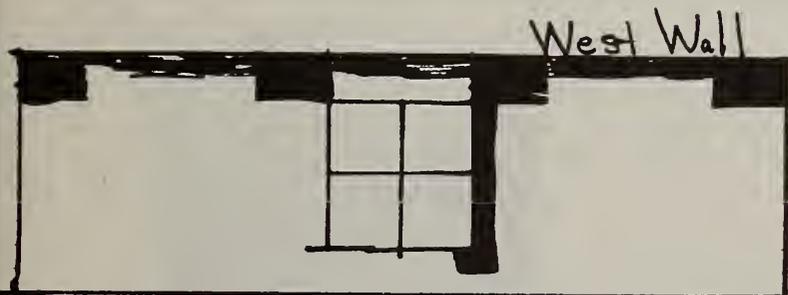
Voids & shrinkage as shown.

Shrinkage around right of window frame resulting in void. 14 ft^2 ✓

15-4
Voids and shrinkage observed in W wall of den (by contractor P1)

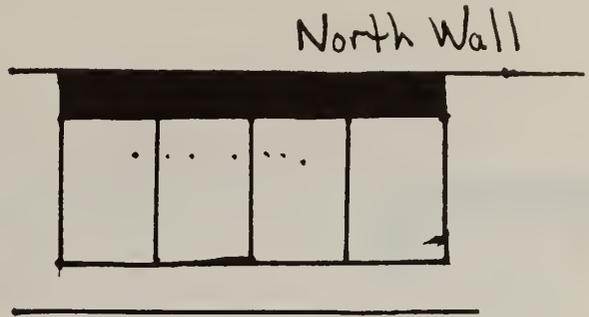
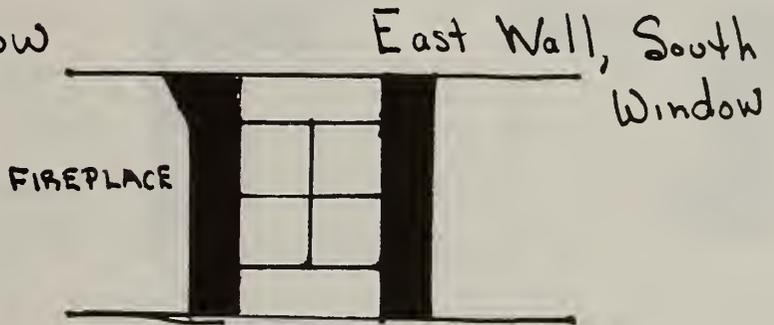
Bay between window and fireplace plus bay to right of window void. 23ft²

Area above picture window uninsulated

16-2
Uninsulated areas observed in living room (by contractor P1)

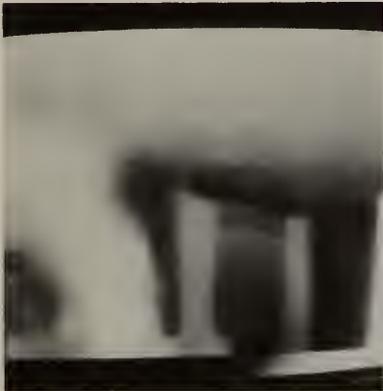
16-3
Voids above window and 1 bay cavity along S side of S window on E wall of living room, & cold area of fireplace chimney on 1st floor (by NBS)

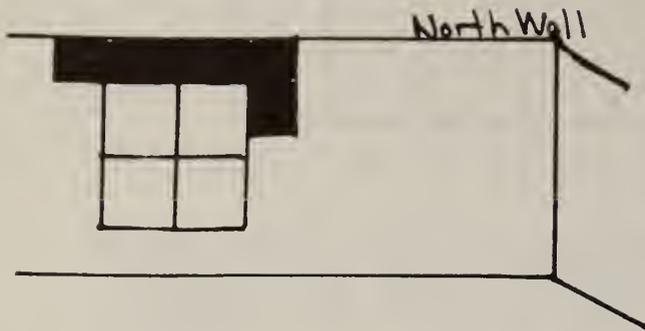
16-6

1st bay to right of window - top 2 1/2 feet void. Over window and to left as shown, appear insufficiently insulated

Insufficient insulation areas observed in master bedroom on the second floor (by contractor P1)

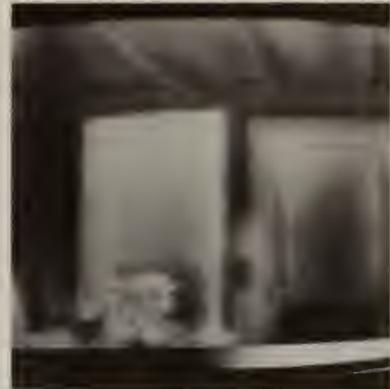
20-3

Missing insulation in bay cavities above corner braces at NW corner of dining room (by NBS)

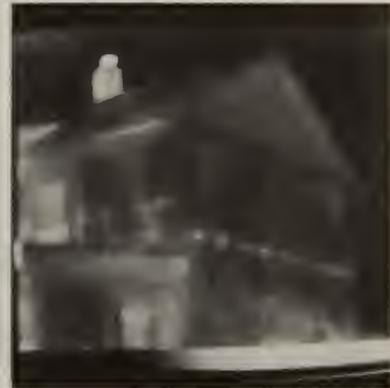
20-9

Exterior thermogram showing warm paths up to attic at NW corner indicating by-pass heat loss (by NBS)

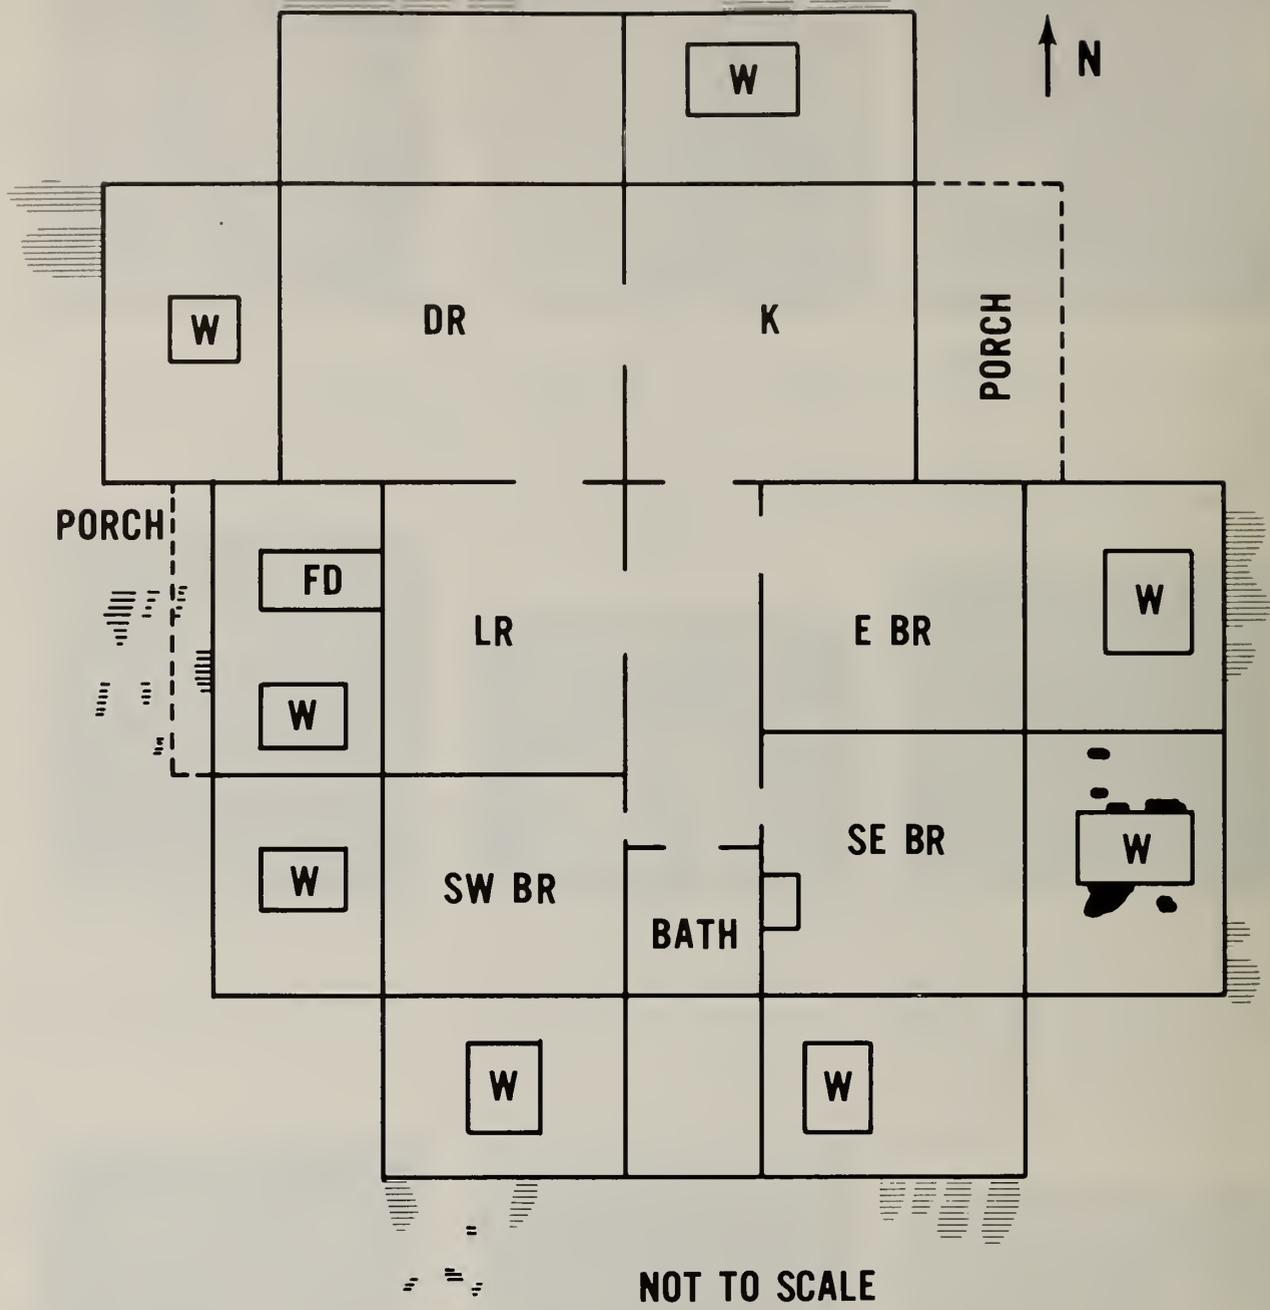
Figure I. Thermal deficiencies observed in ceiling and southeast bedroom of Atlanta house #1

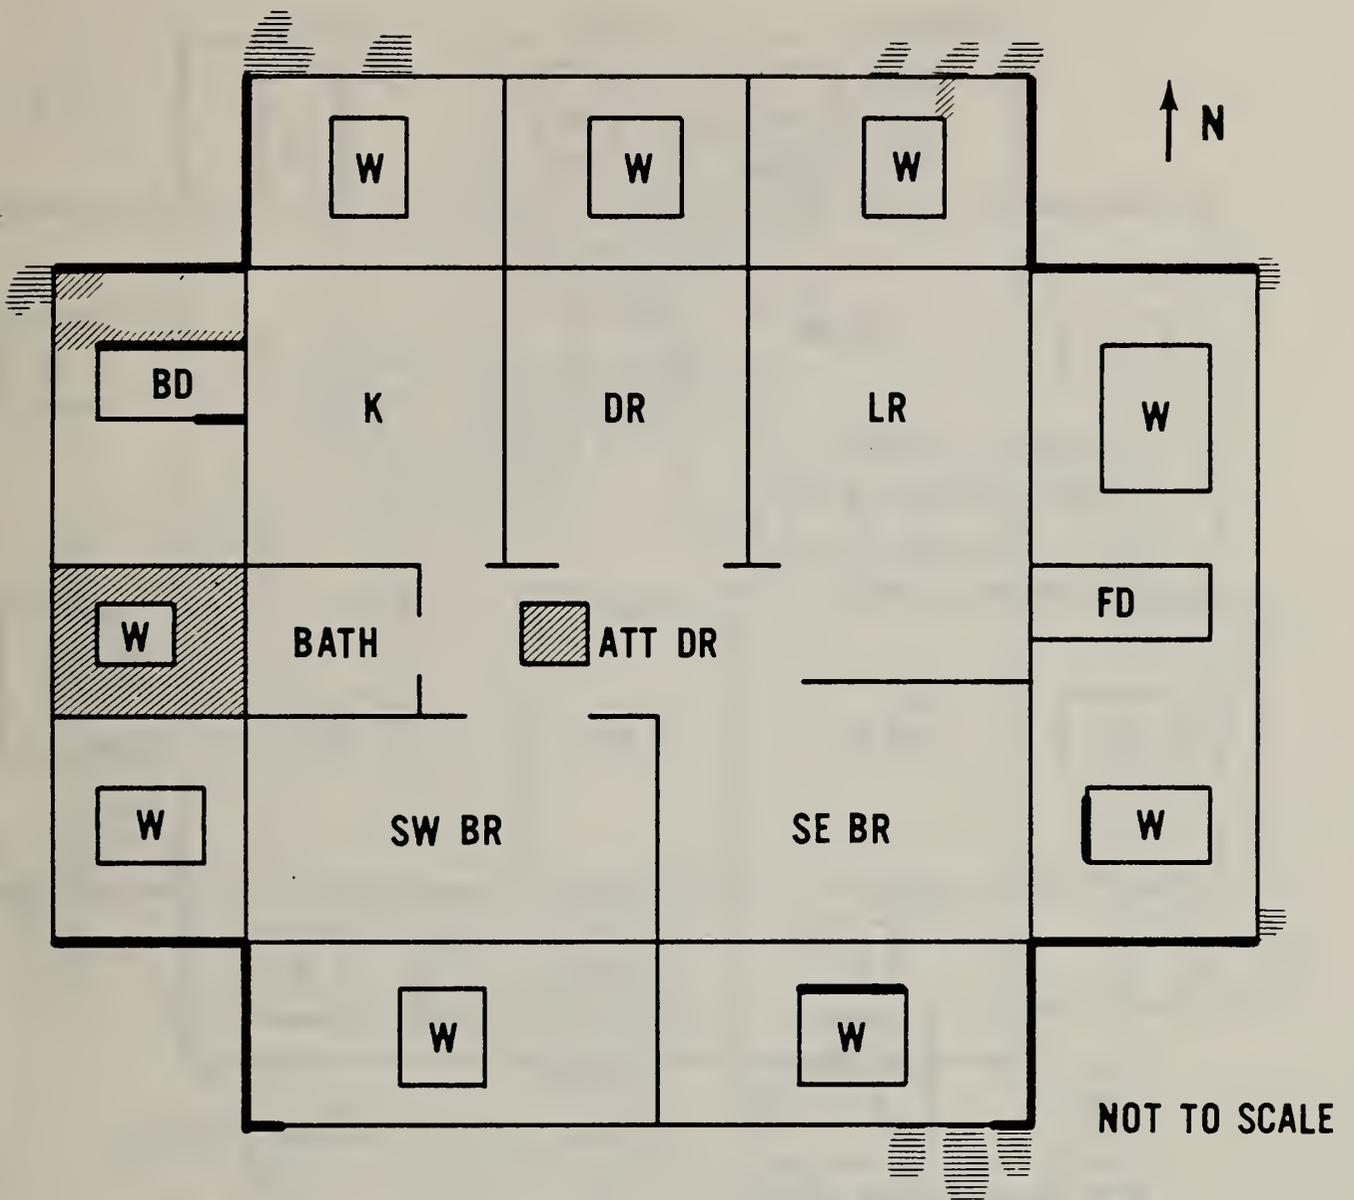
Figure II. Thermal deficiencies observed in Atlanta house #2

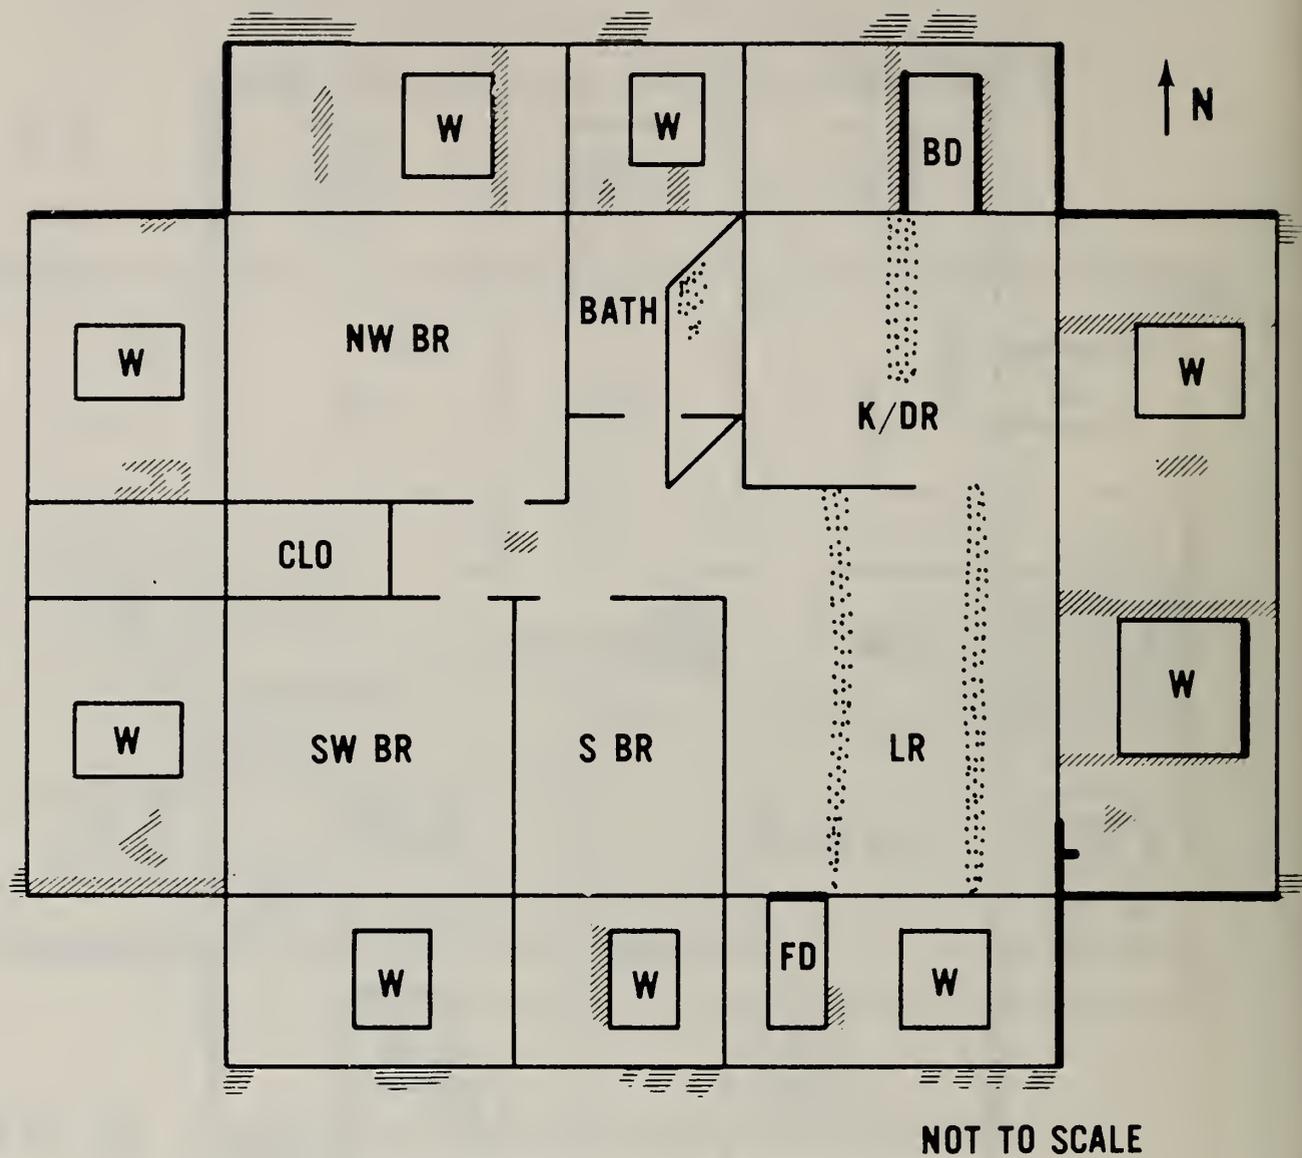
Figure III. Thermal deficiencies observed in Atlanta house #3

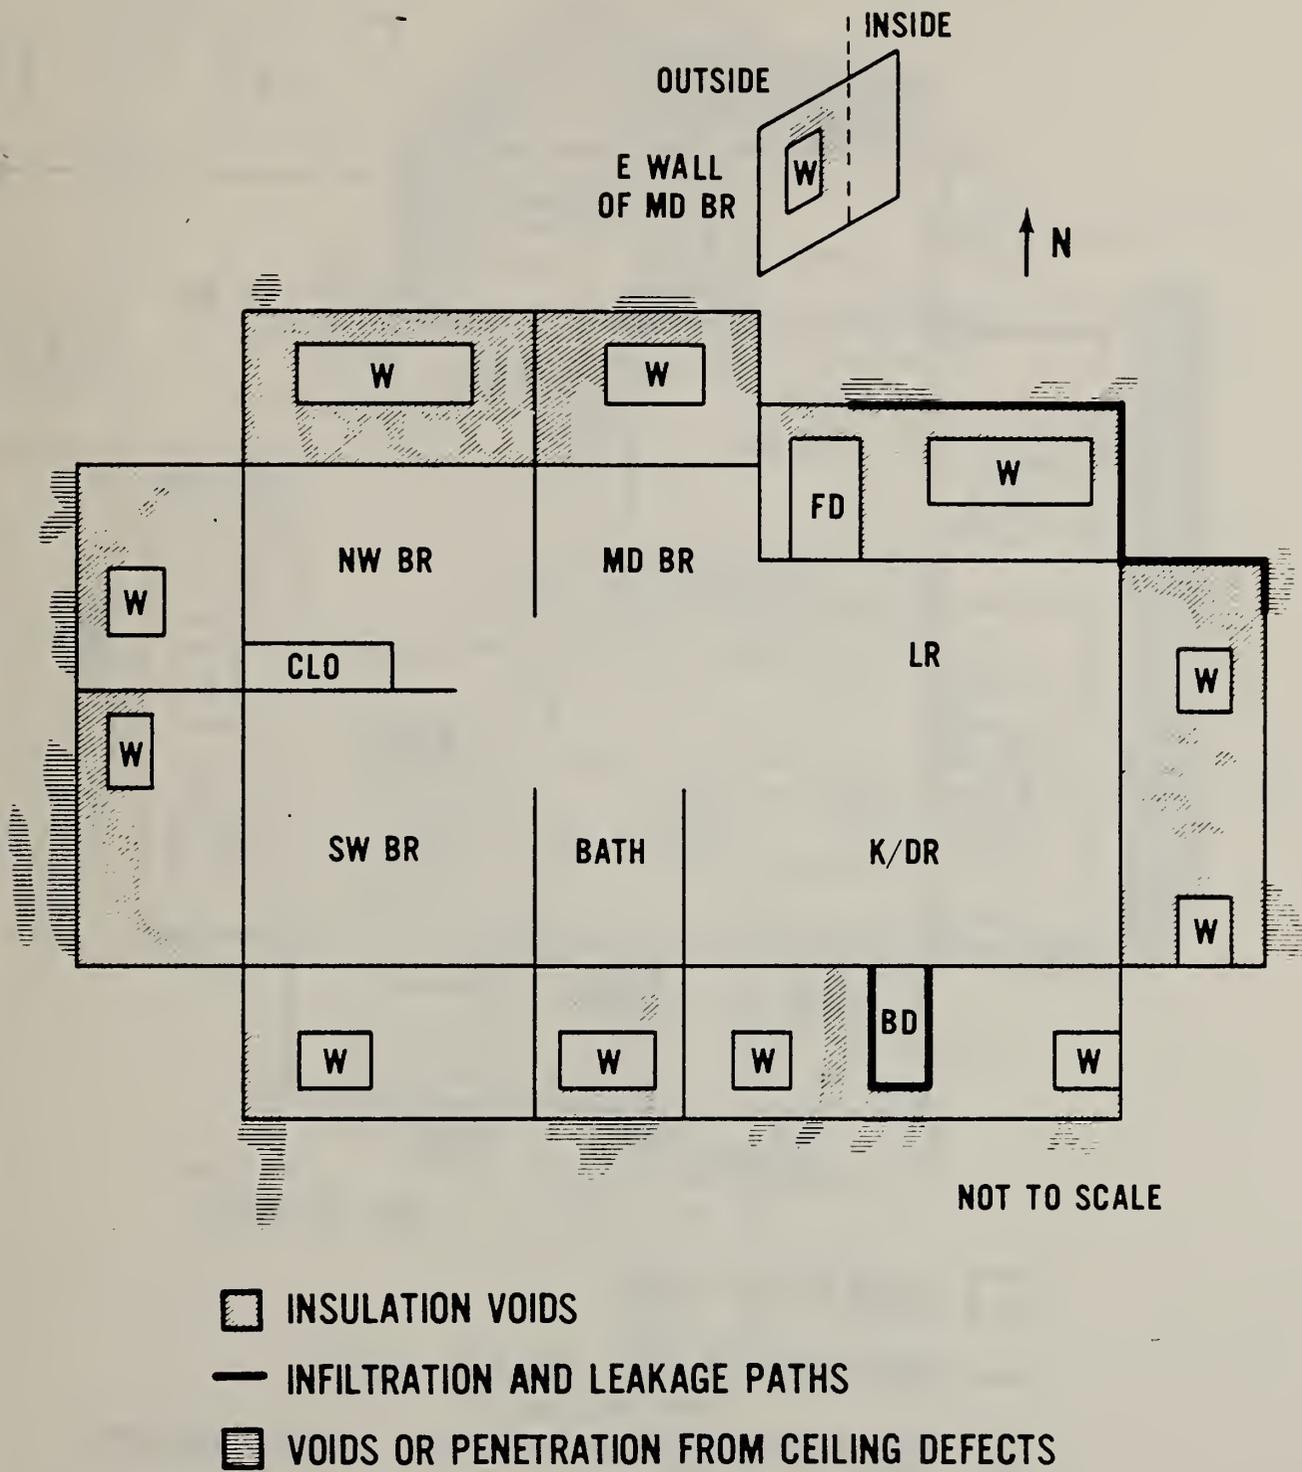
Figure IV. Thermal deficiencies observed in Atlanta house #4

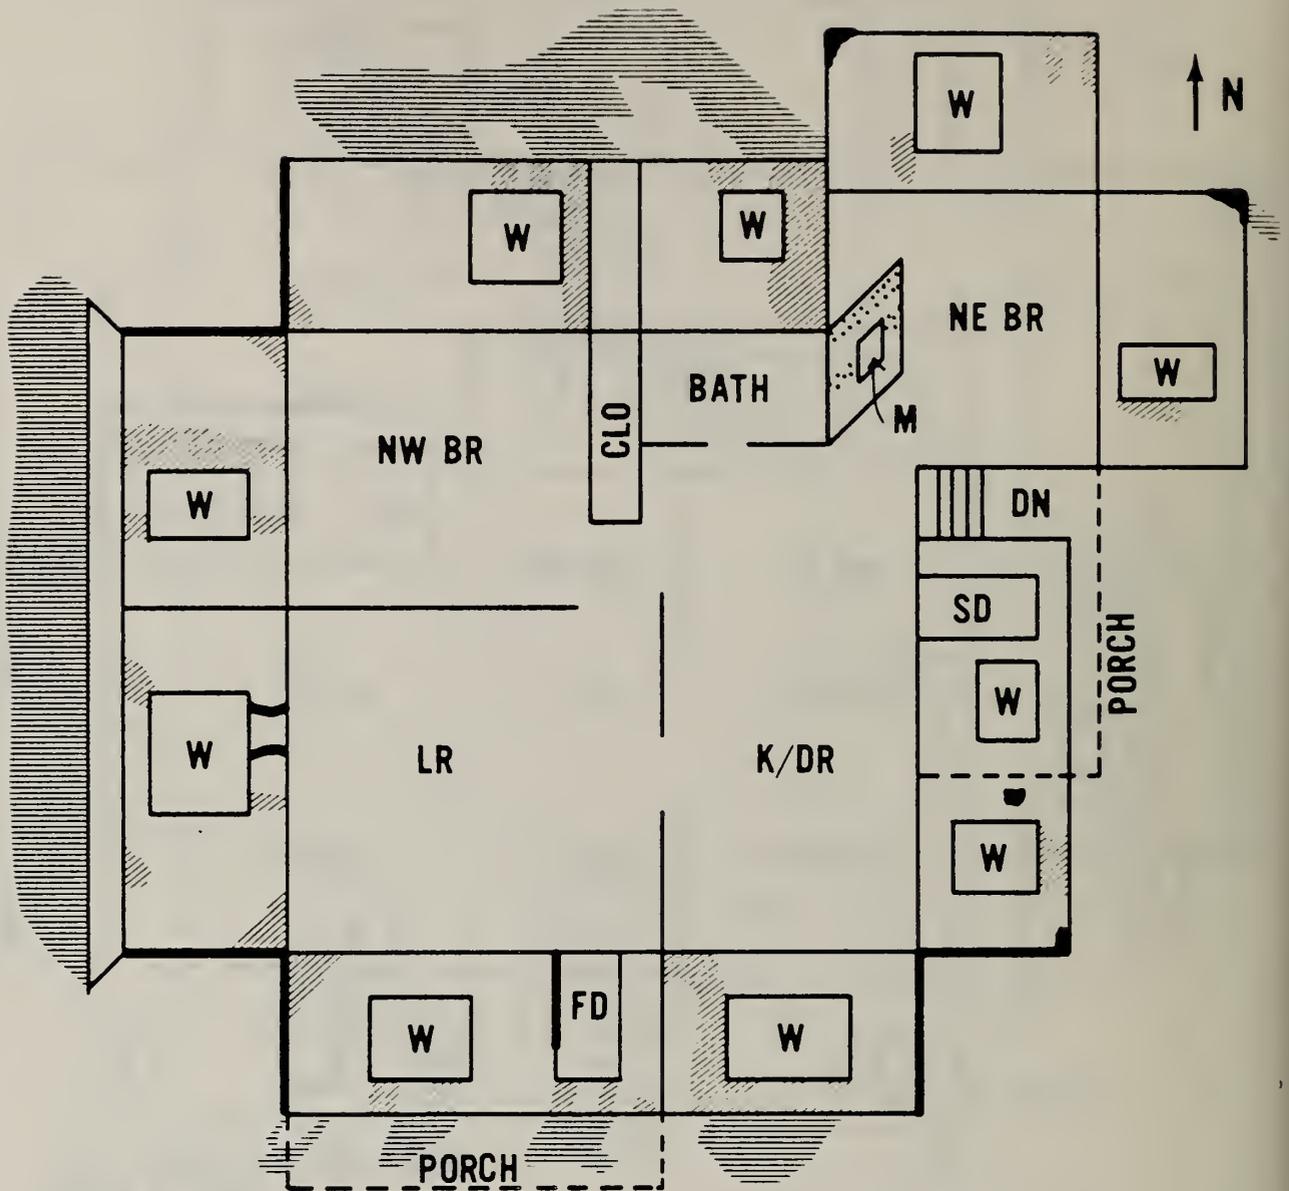
Figure V. Thermal deficiencies observed in Colorado Springs house #1

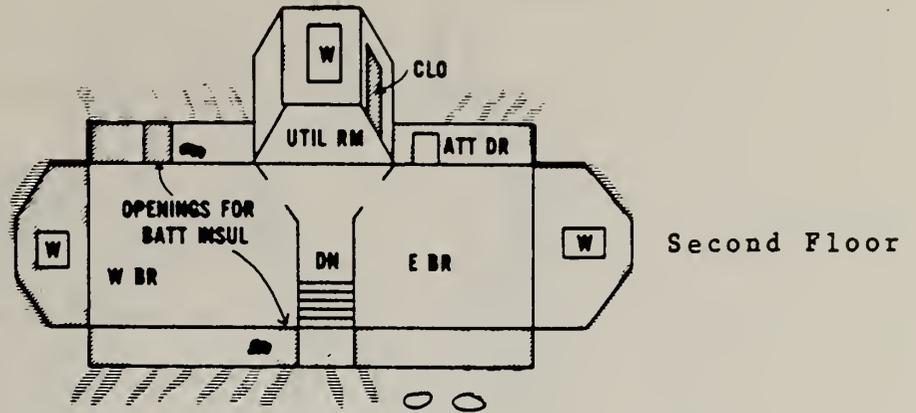
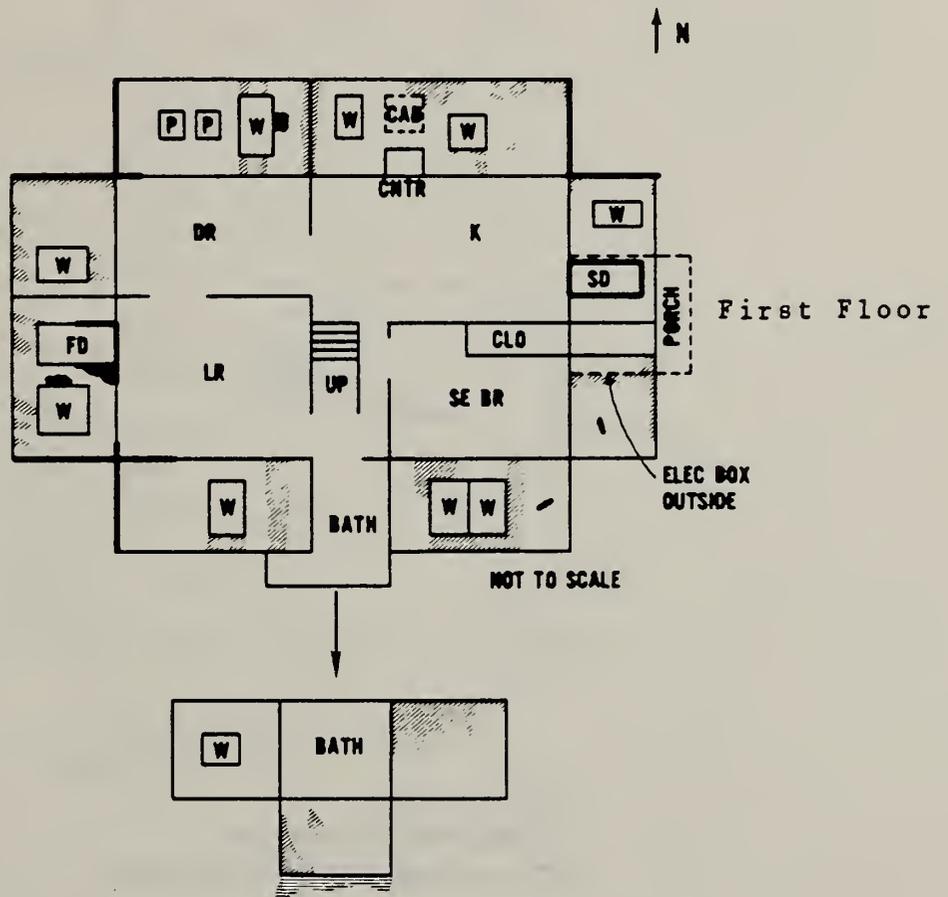
Figure VI. Thermal deficiencies observed in Colorado Springs house #2

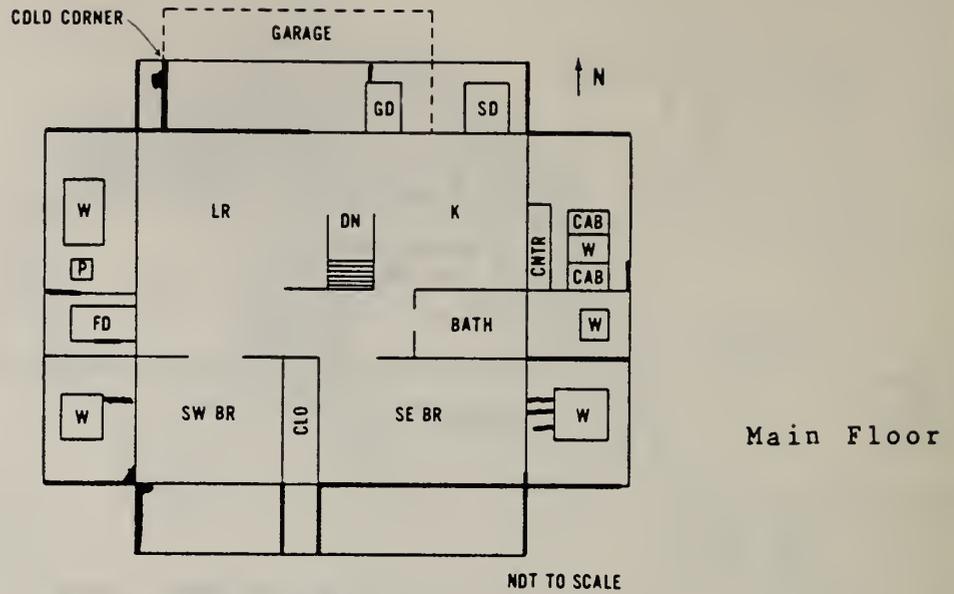
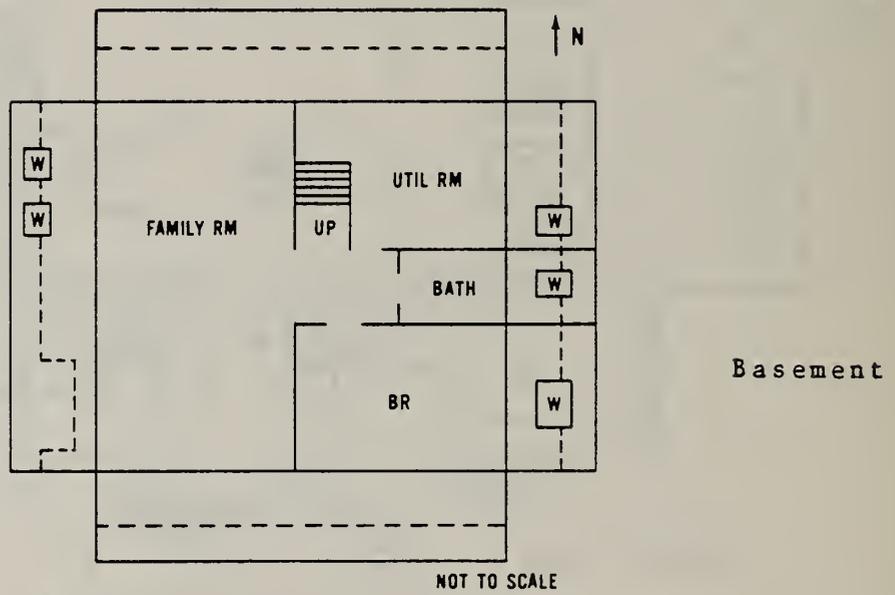
Figure VII. Thermal deficiencies observed in Colorado Springs house #3

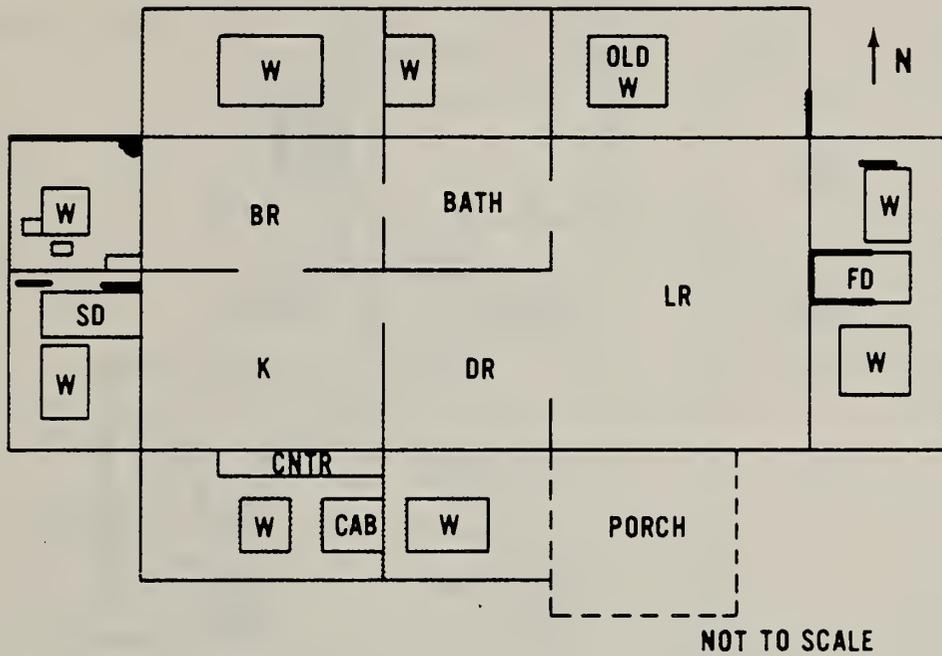
Figure VIII. Thermal deficiencies observed in Colorado Springs house #4

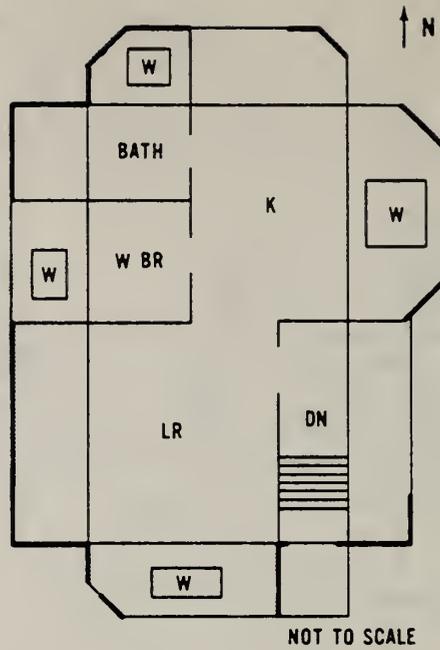
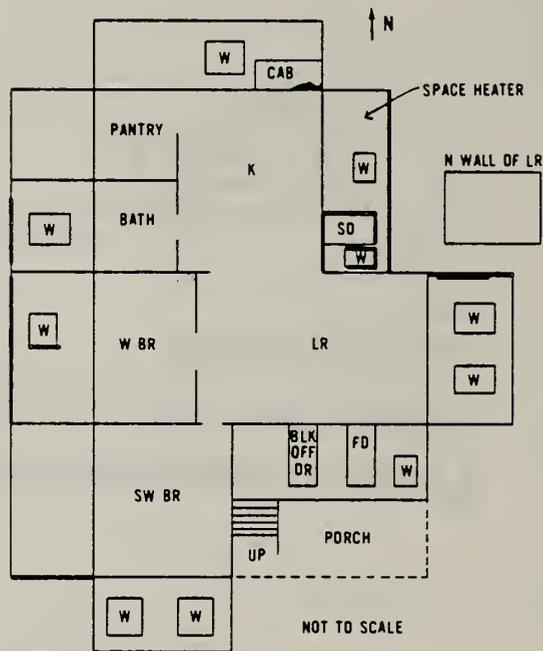
Figure IX. Thermal deficiencies observed in Minneapolis-St. Paul house #1

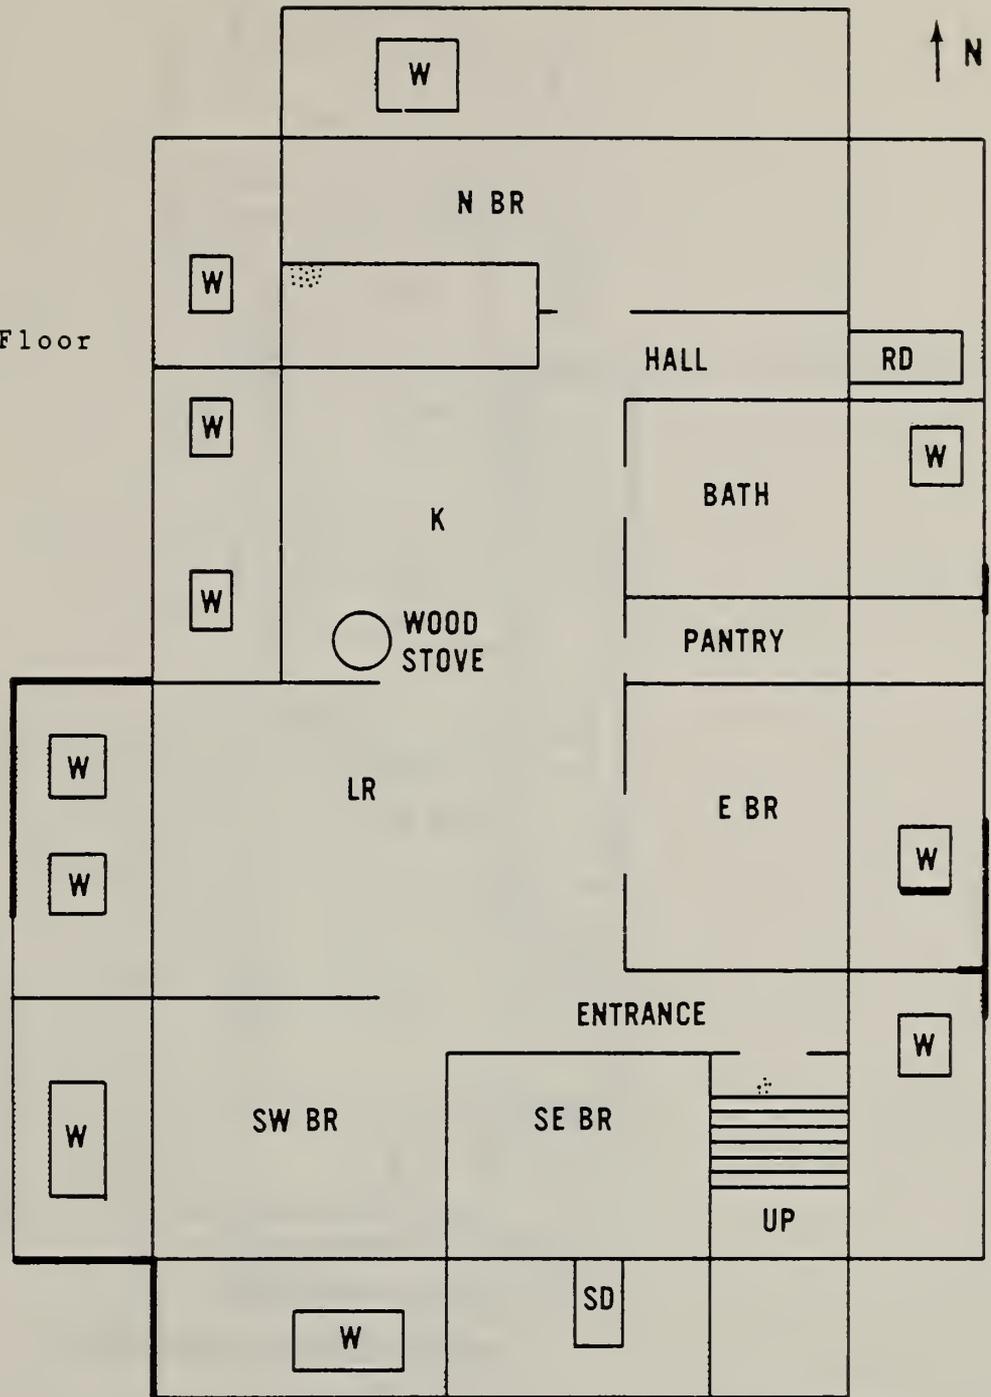
Figure X. Thermal deficiencies observed in Minneapolis-St. Paul house #2

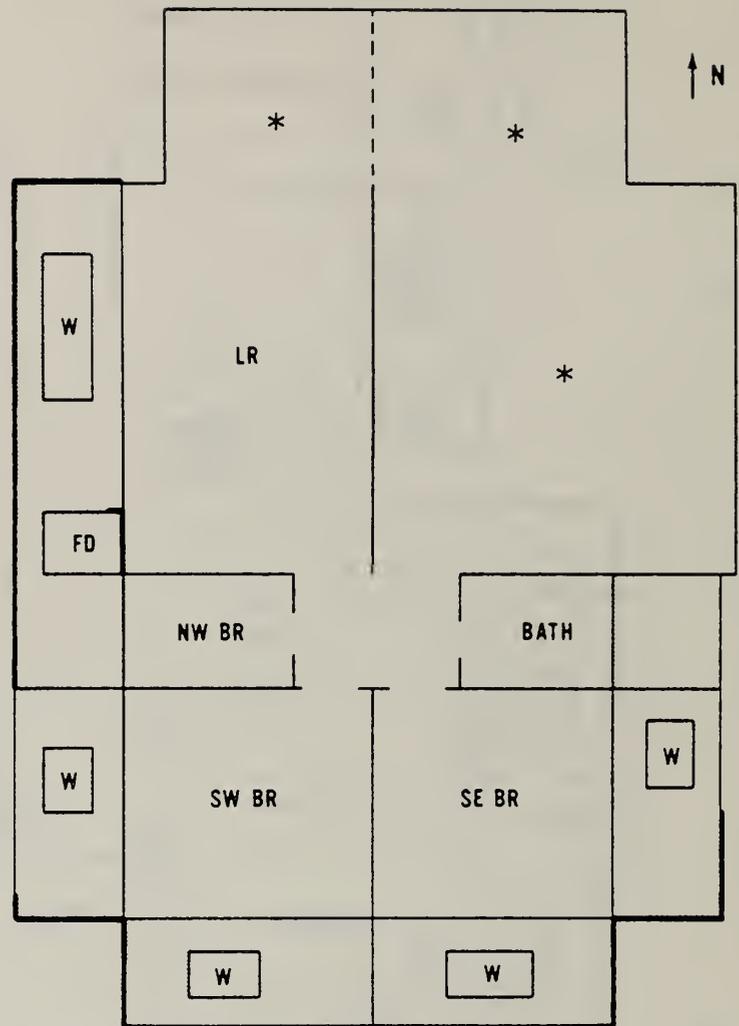
Figure XI. Thermal deficiencies observed in Minneapolis-St. Paul house #3

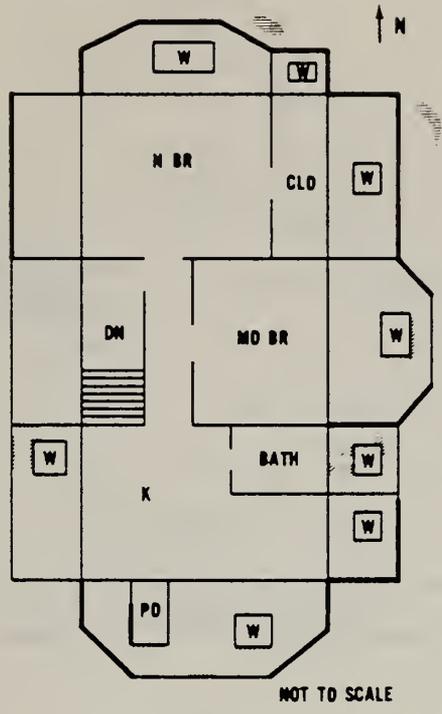
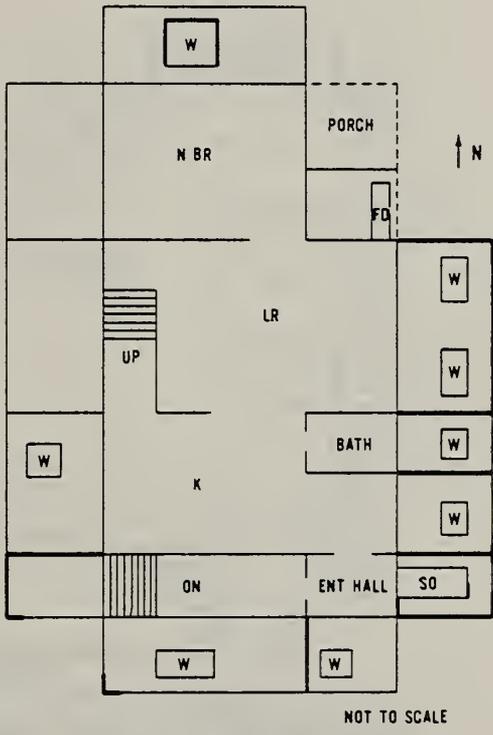
Figure XII. Thermal deficiencies observed in Minneapolis-St. Paul house #4

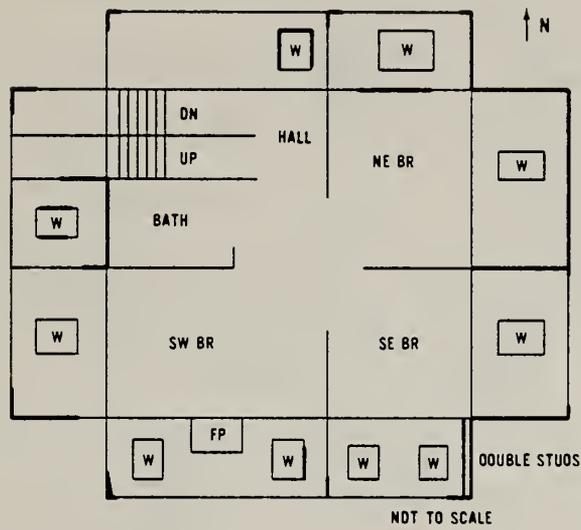
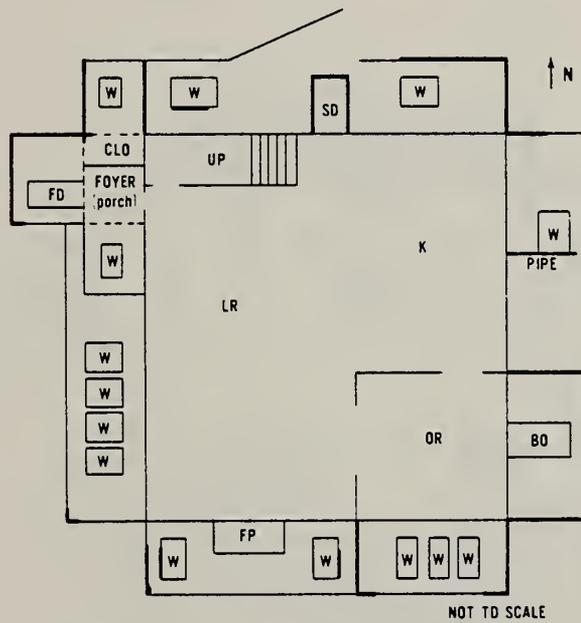
Figure XIV. Thermal deficiencies observed in Providence house #2

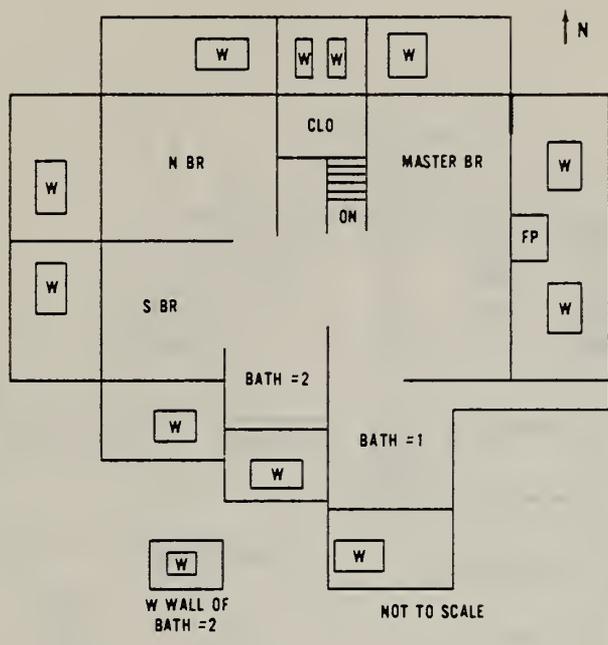
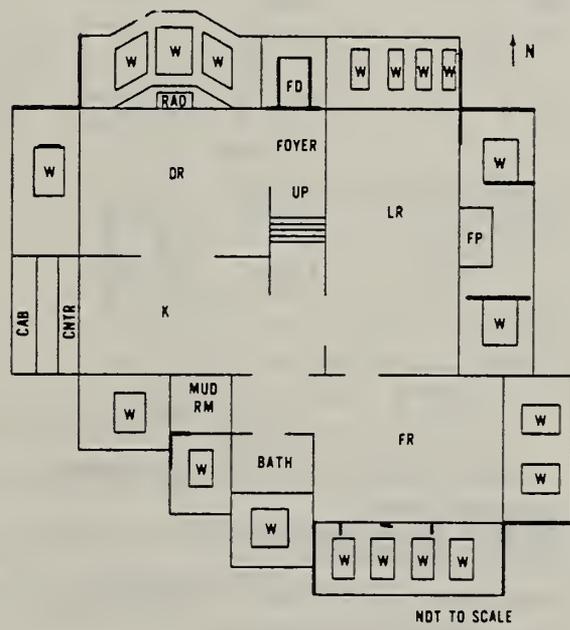
Figure XVI. Thermal deficiencies observed in Providence house #4

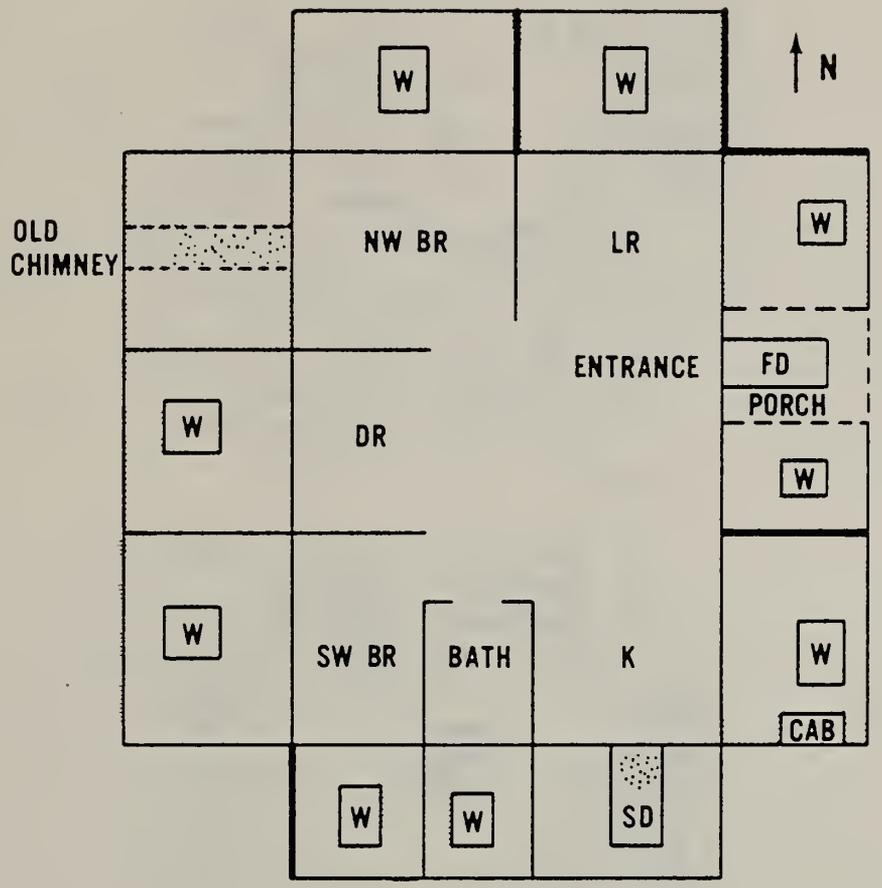
Figure XVIII. Thermal deficiencies observed in Washington, D.C. house #2
